[Docket No. FAA-2015-3989; Directorate Identifier 2014-NM-250-AD; Amendment 39-18600; AD 2016-16-02]

Airworthiness Directives; Airbus Airplanes

ACTION: Final rule.

2016-16-02 Airbus: Amendment 39-18600. Docket No. FAA-2015-3989; Directorate Identifier 2014-NM-250-AD.

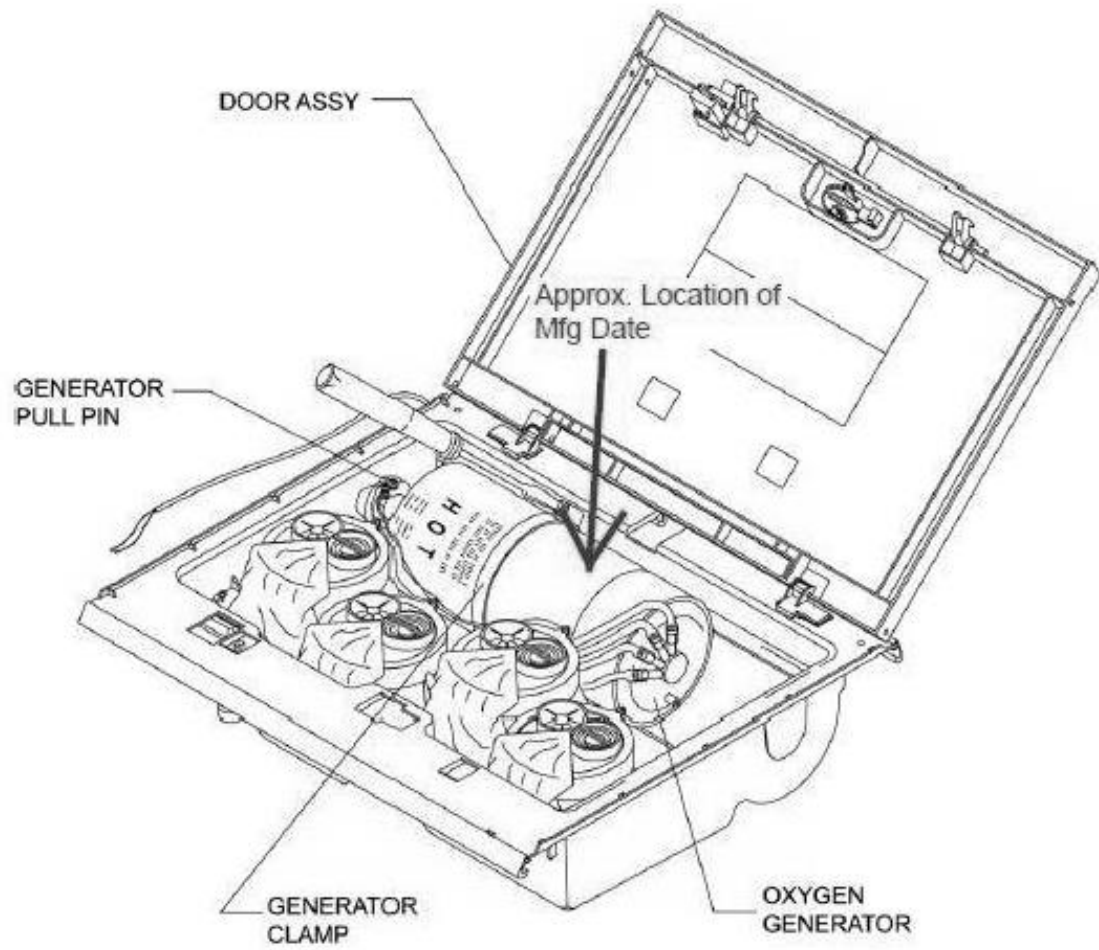
Figure 1 to Paragraph (g) of this AD - Location of Date (MM-YY)

Within 30 days after the effective date of this AD: Do a one-time inspection of passenger chemical oxygen generators, part numbers (P/N) 117042-02 (15 minutes (min) – 2 masks), 117042-03 (15 min – 3 masks), 117042-04 (15 min – 4 masks), 117042-22 (22 min – 2 masks), 117042-23 (22 min – 3 masks), and 117042-24 (22 min – 4 masks) to determine the date of manufacture as specified in Airbus Alert Operators Transmission (AOT) A35N006-14, dated December 10, 2014, including Appendix 1. Refer to figures 1 and 2 to paragraph (g) of this AD for the location of the date. A review of airplane maintenance records is acceptable for the inspection required by this paragraph, provided the date of manufacture can be conclusively determined by that review.

If, during any inspection required by paragraph (g) of this AD, any passenger chemical oxygen generator having a date of manufacture in 1999, 2000, or 2001 is found: At the applicable time specified in paragraph (h)(1), (h)(2), or (h)(3) of this AD, remove and replace the affected passenger chemical oxygen generator with a serviceable unit, in accordance with Airbus AOT A35N006-14, dated December 10, 2014, including

Appendix 1 (for 15-minute and 22-minute passenger chemical oxygen generators); or the Accomplishment Instructions of B/E Aerospace Service Bulletin 117042-35-001, Revision 004, dated October 13, 2015 (for 15-minute passenger chemical oxygen generators).
